# CITY of MOUNT DORA

## Historic Design Guidelines

# City of Mount Dora Historic Design Guidelines

**A** guide to Historic Preservation,  
Rehabilitation & New Construction in the  
City of Mount Dora, FL.

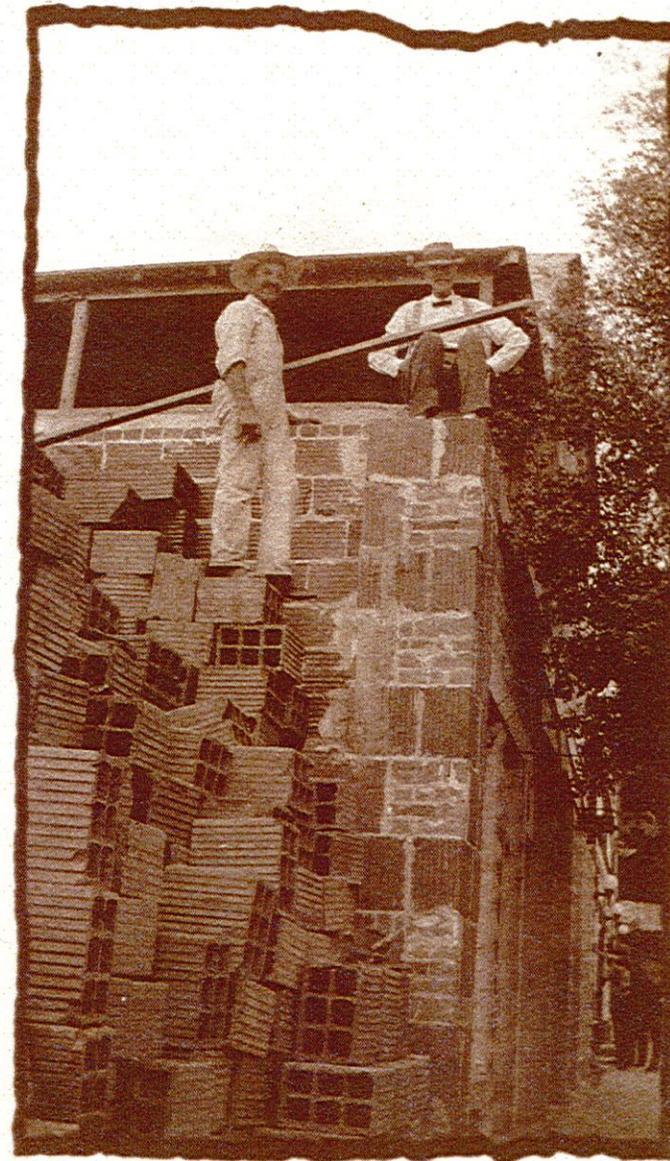
*A.J. Waltz and  
Monroe  
Patterson using  
hollow terra  
cotta Egyptian  
block to  
construct the  
Mount Dora  
Hotel (now the  
Renaissance  
Center)  
downtown on  
Donnelly Street,  
1923.*

Beginning in the 1920s, two new masonry materials, hollow terra cotta tile and concrete block, gained wide use in construction of commercial buildings. In Mount Dora "Risley Block", a cut-face or rusticated block, locally produced by Carl Risley behind his home on Tremain Street, became popular. As strong as fired brick, the new materials were lighter and cheaper.

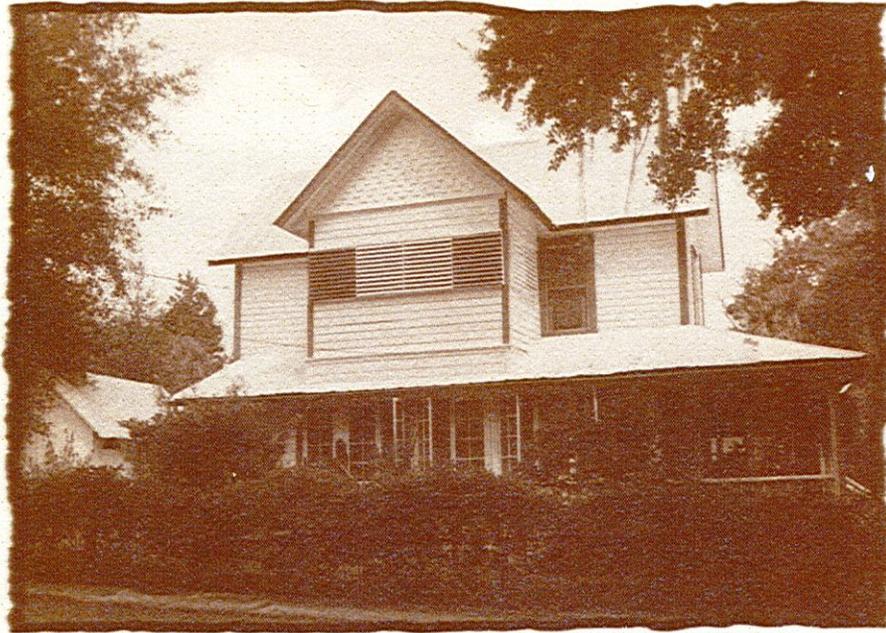
*The Col.  
Alexander  
House on  
8th Avenue,  
built circa  
1889.*

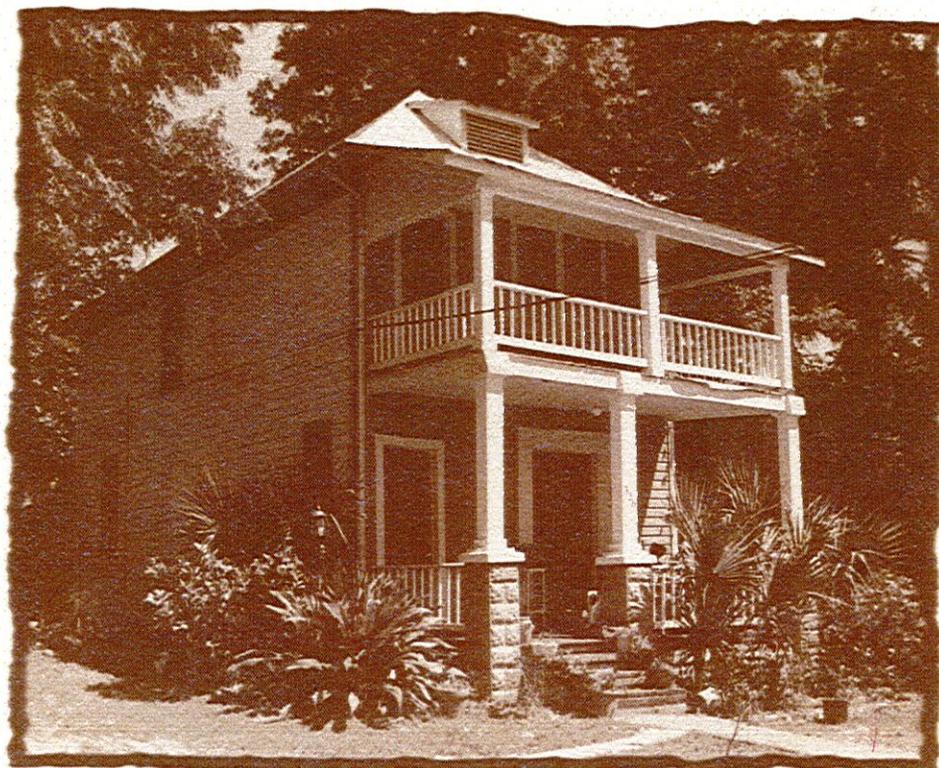
*The Cross House on  
Tremain Street was  
built circa 1915.*

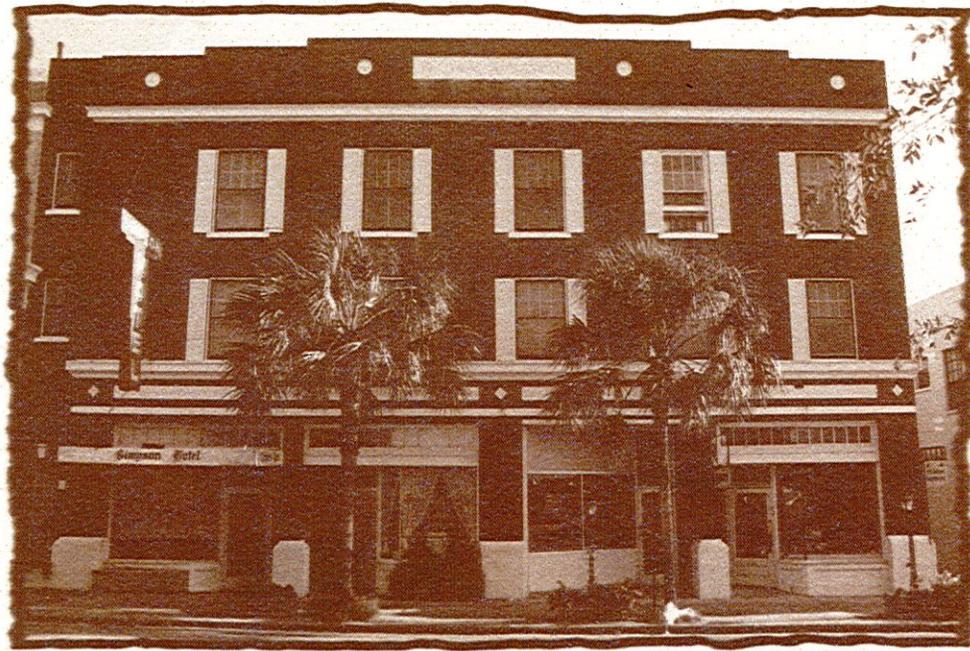
*Built on 5th Avenue  
circa 1923 & designed  
by architect James  
Gamble Rogers II, the  
Simpson Hotel was  
famous for being totally  
fireproof.*

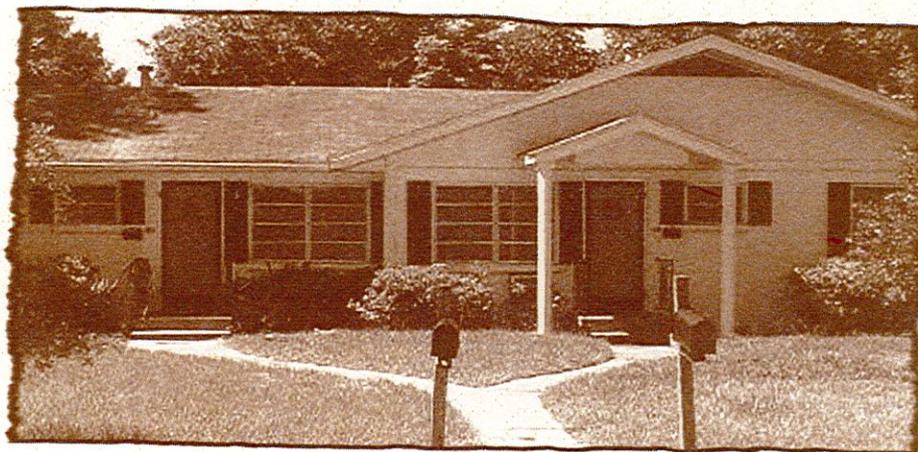
*The Ranch homes pictured on these pages are all built of either concrete block or Ocala Brick.*

In Mount Dora, Ranch homes are constructed primarily of concrete block or Ocala Brick. In the homes built of concrete block, the block often has a bullnose profile on the intersecting corners. Ocala Brick is a pale gray or buff color, smooth surfaced, with a long narrow profile and is usually painted.

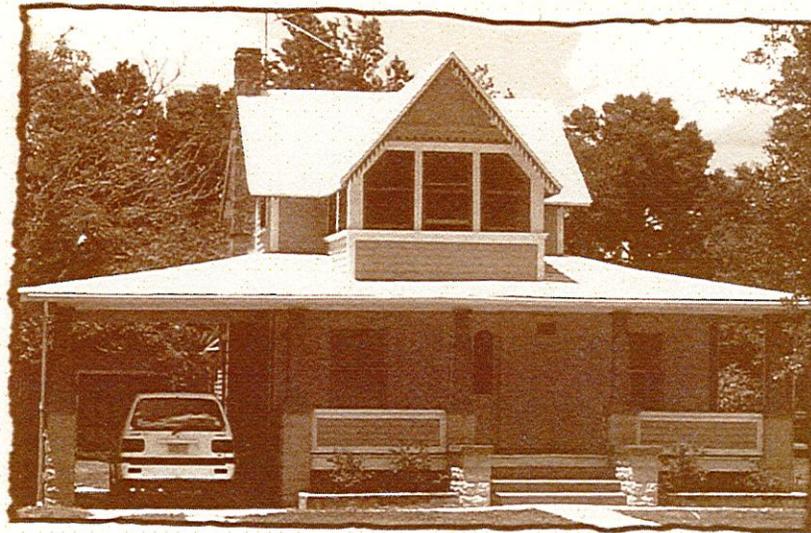
*This Craftsman porch & porte cochere was added to the Farnsworth-Koch House in the 1920s & enclosed at a later date.*

*An excellent example of restoration, the porch, historic in its own right, has been opened as it was originally intended.*

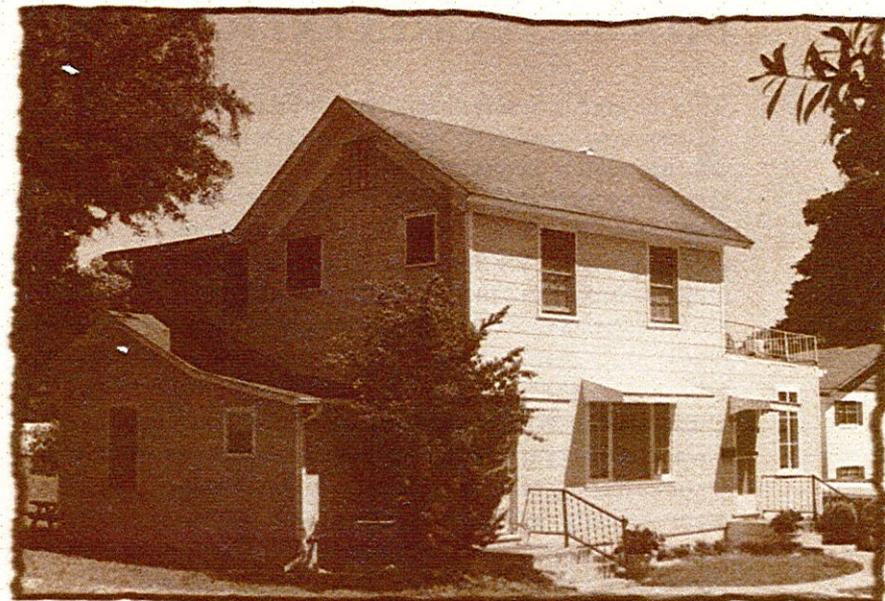
*The Massey House, built in 1884, has suffered such insensitive "remuddling" during its 117 years that it is nearly unrecognizable today. Fortunately, it still stands. (below)*

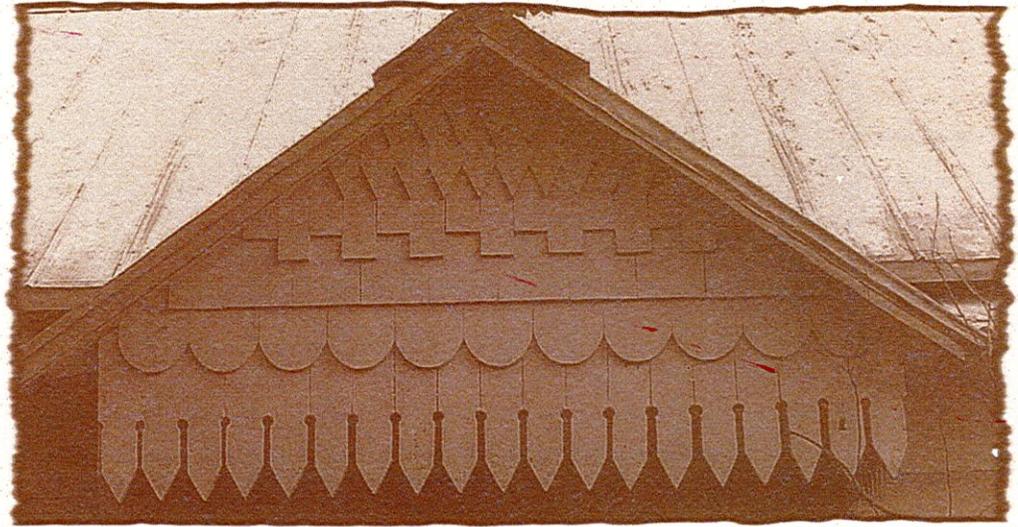
*This novelty siding has been kept  
in good repair.*

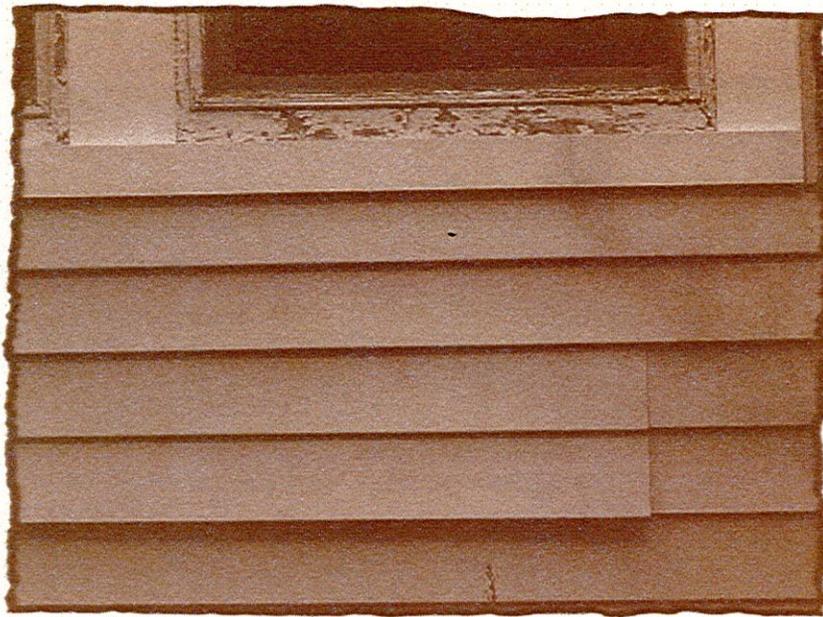
*This clapboard  
has been  
inappropriately  
clad in  
aluminum siding  
that is now  
pulling away  
from the  
clapboard.*

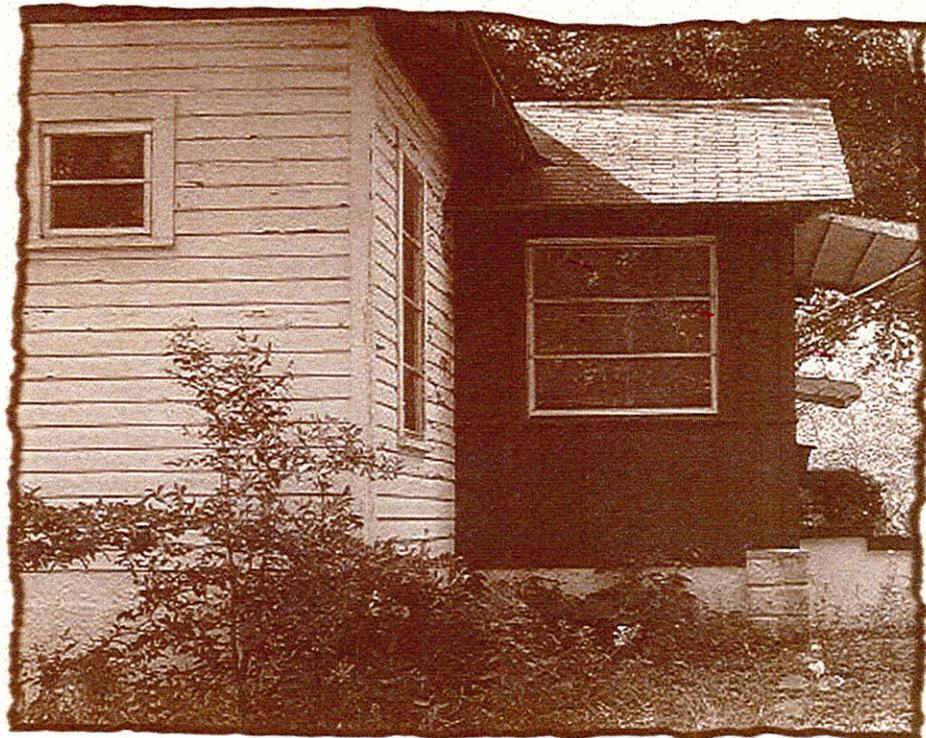
*This historic cottage has suffered from poor maintenance, inappropriate replacement windows & an addition crafted of materials incompatible with the original structure.*

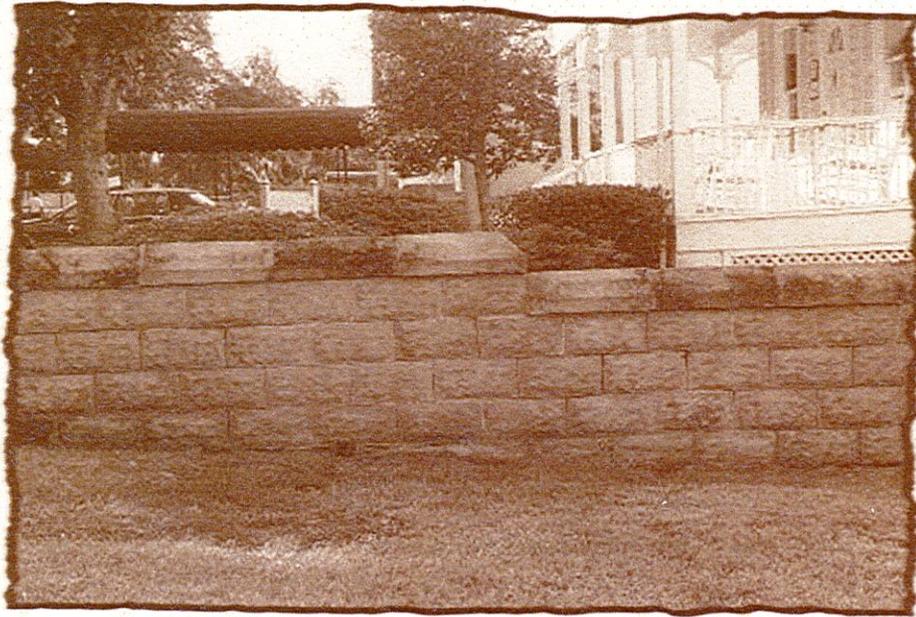
*This rusticated  
"Risley block" wall  
at the Lakeside Inn  
has been well-  
maintained and,  
fortunately, never  
painted.*

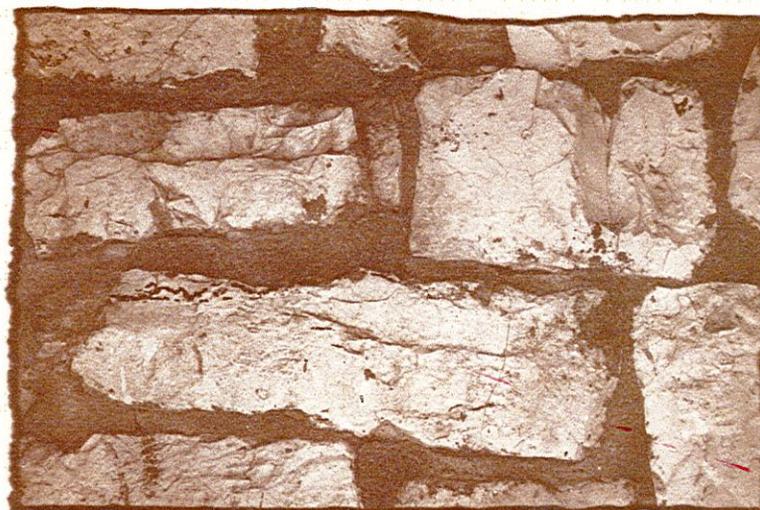
*This fieldstone foundation has been carefully & appropriately maintained throughout the years.*

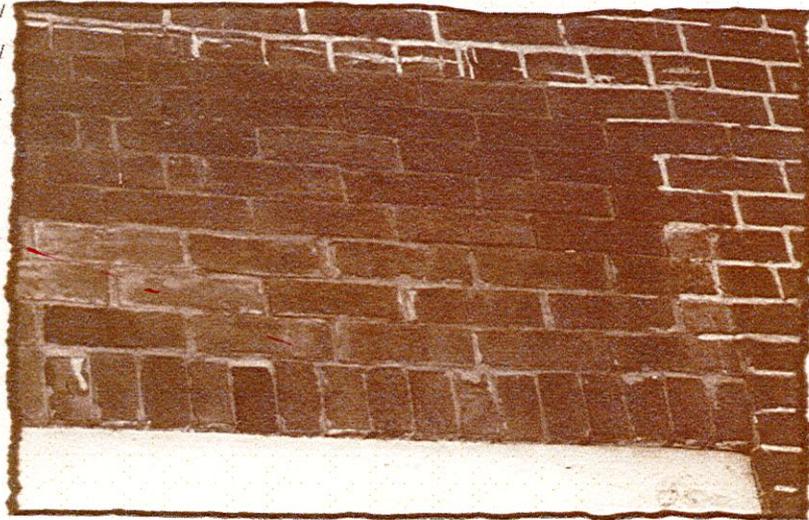
*These walls  
have been  
successfully  
preserved  
using infill  
brick.*

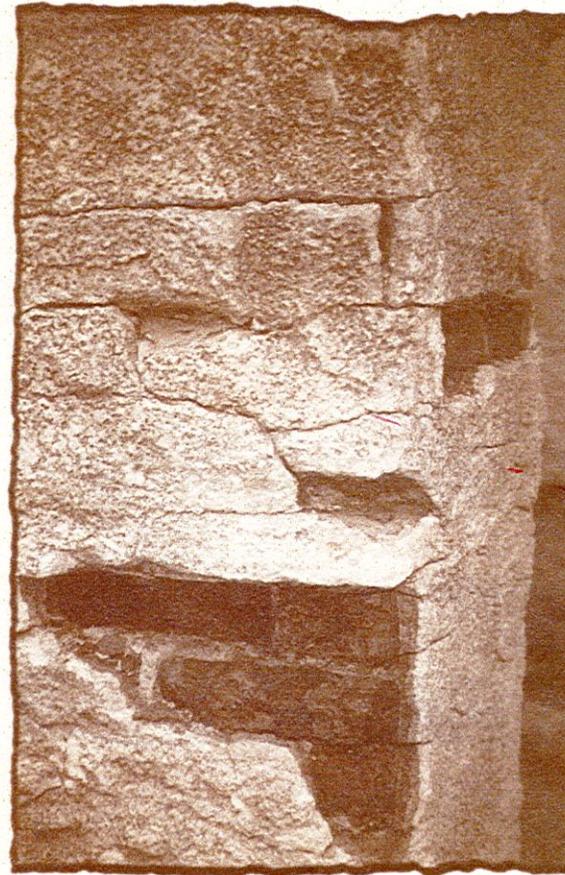
*The stucco parging on this column has been allowed to deteriorate, exposing the soft brick underneath to the elements.*

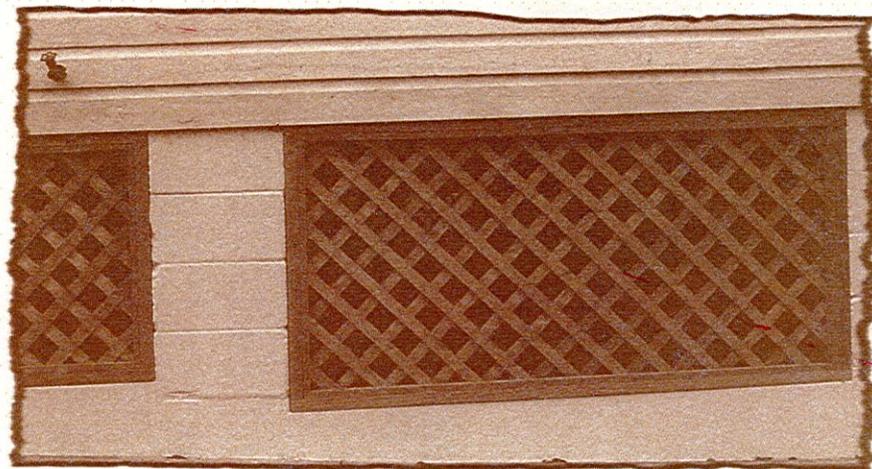
*Lattice infill  
between masonry  
piers*

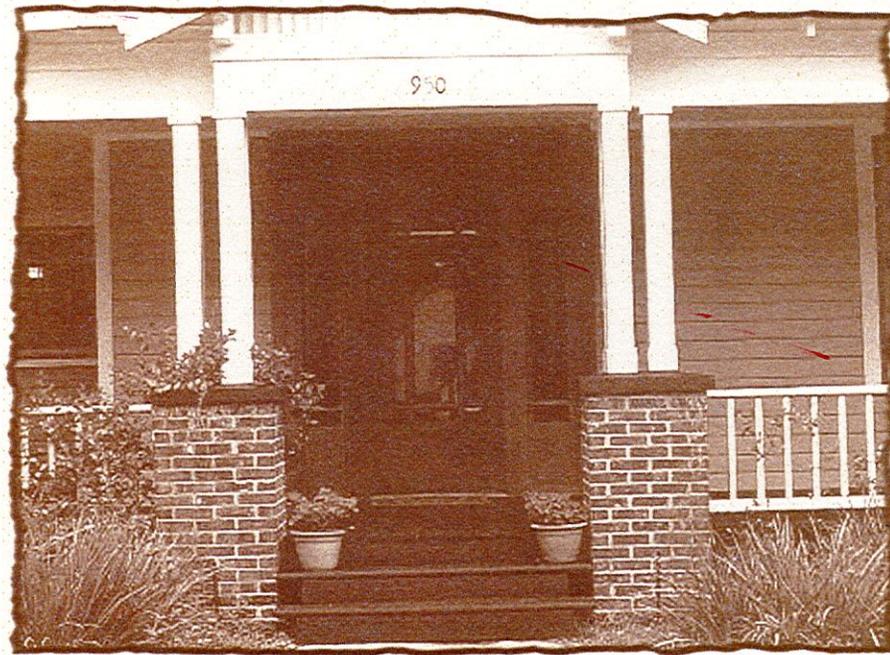
*This doorway, with transom & sidelights was purchased from a salvage yard & is an appropriate entryway to the Keller House built on McDonald St. circa 1914.*

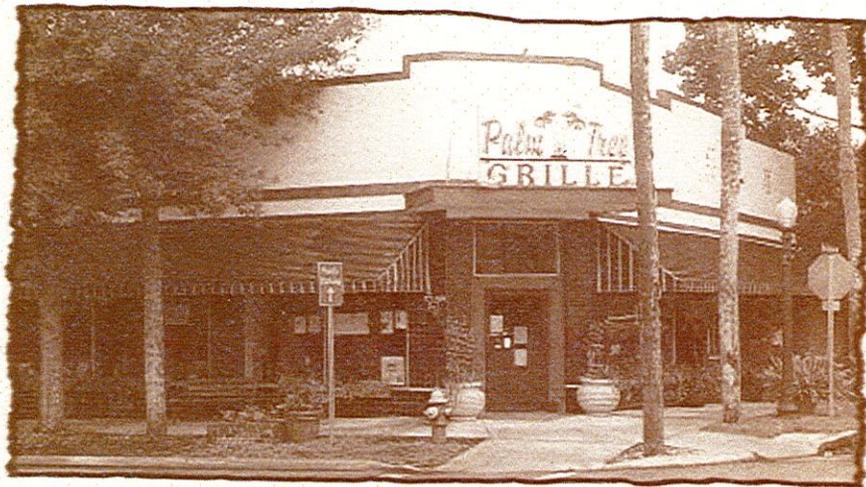
Built circa 1938  
as a "Five &  
Dime", this  
building on the  
corner of  
Donnelly & 4th  
Avenue retains  
its original  
louvered metal  
awnings.

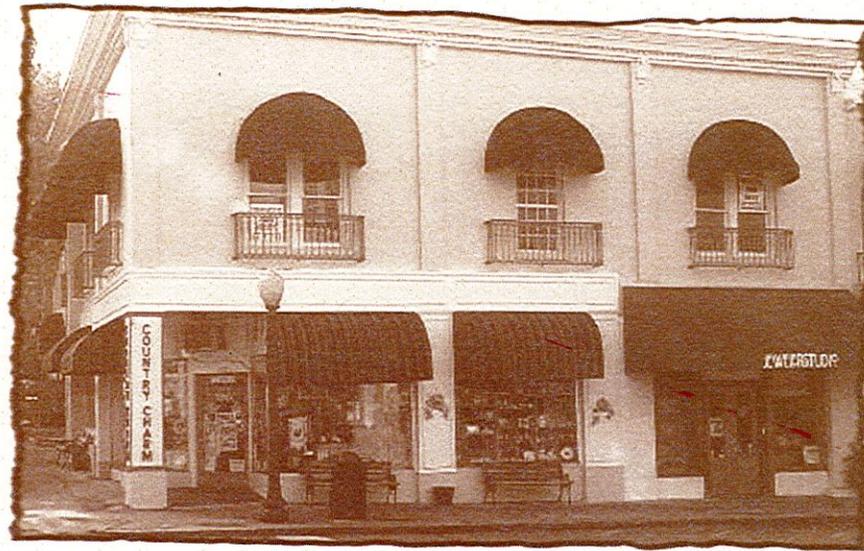
*The domed awnings enhance the windows & bays of this retail shop.*

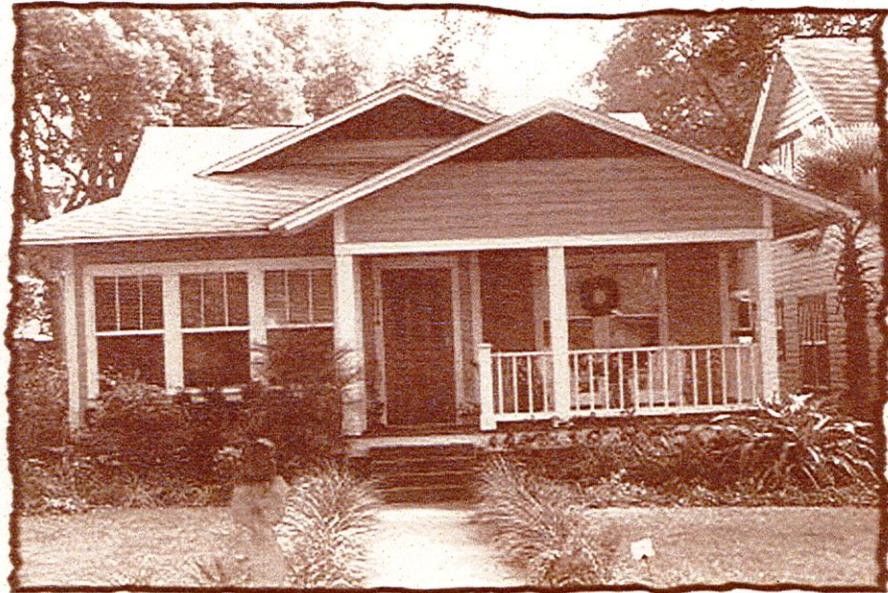
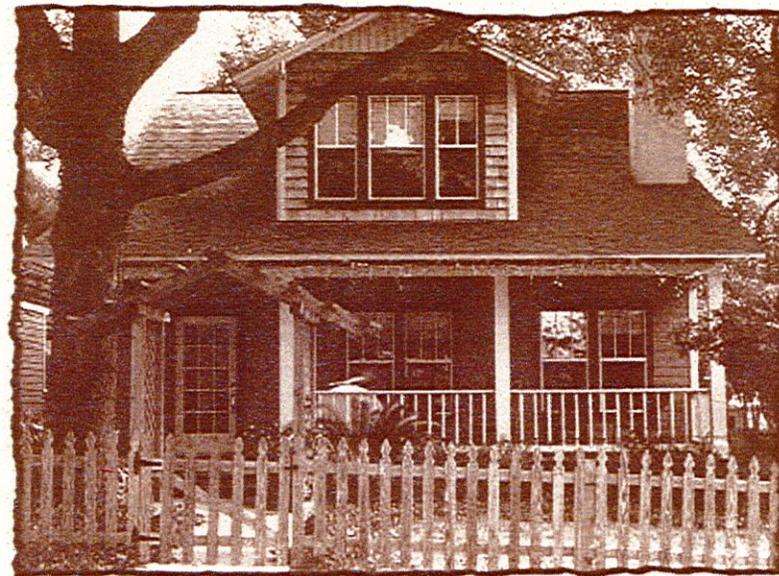
*These two new bungalows appropriately compliment the existing character of the neighborhood.*

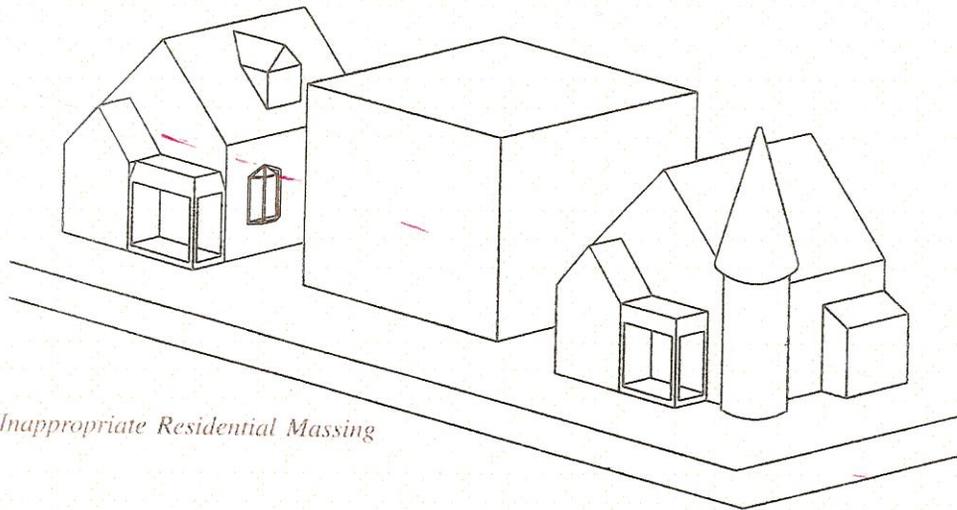
*Inappropriate Residential Massing*

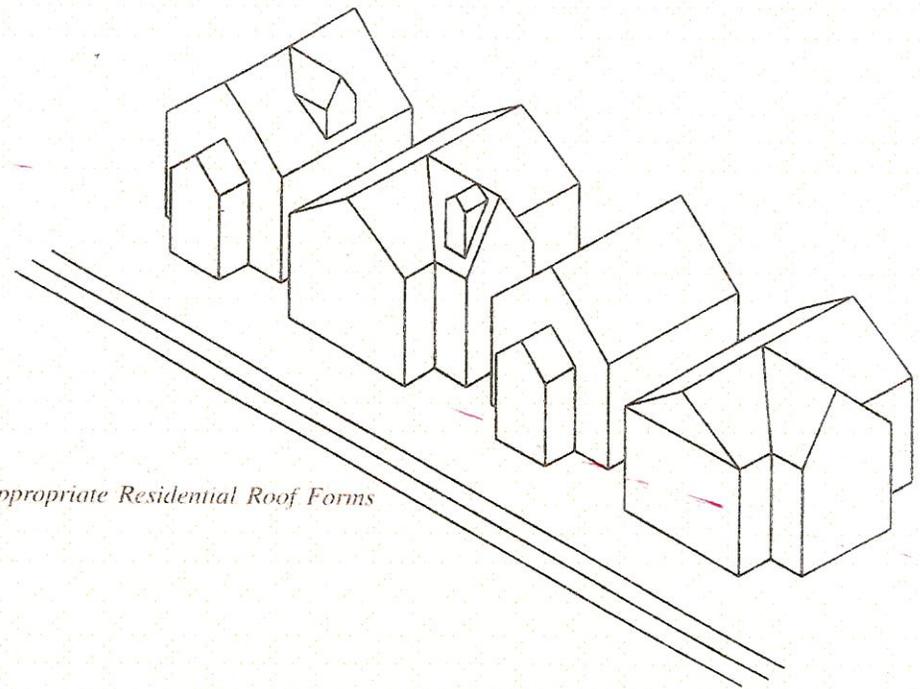
*Appropriate Residential Roof Forms*

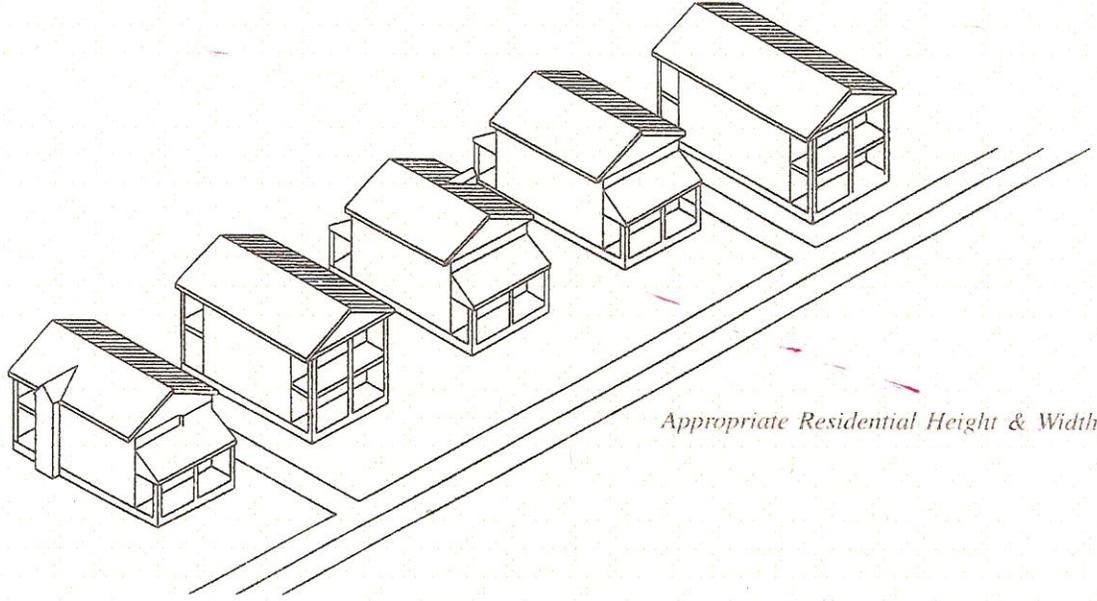
*Appropriate Residential Height & Width*

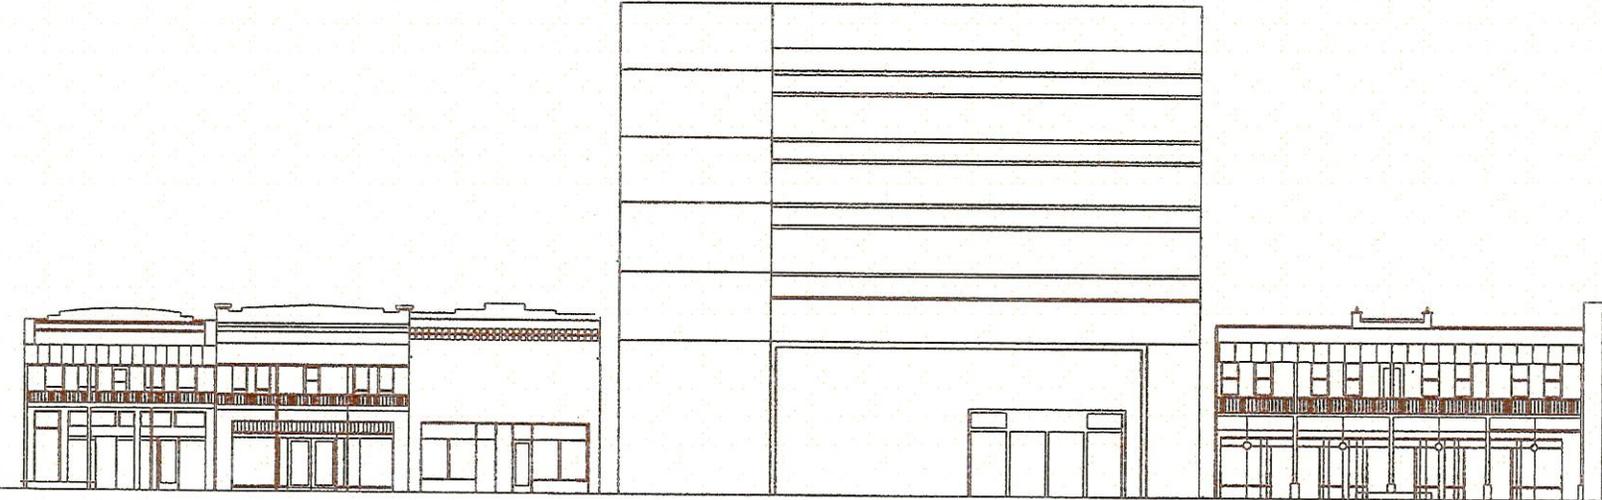
*Commercial Building, Inappropriate Height & Width*

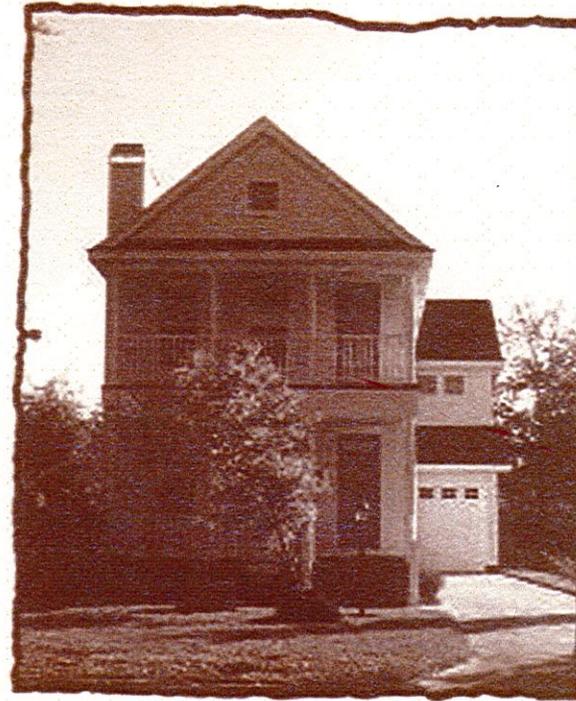
*This new  
infill building  
takes  
advantage of  
its narrow lot  
& setbacks  
while  
respecting the  
character of  
the  
neighborhood.*

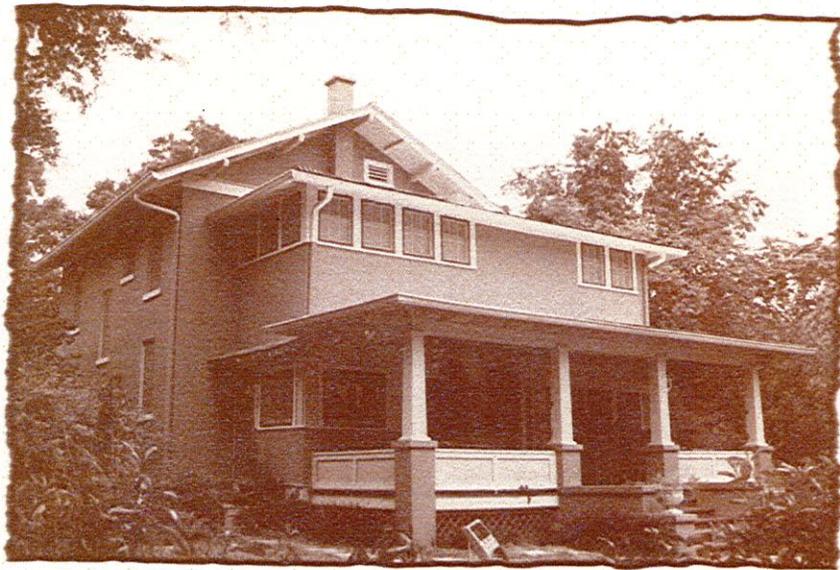
*This new rear porch addition is an appropriate compliment to the original Arts & Crafts home.*

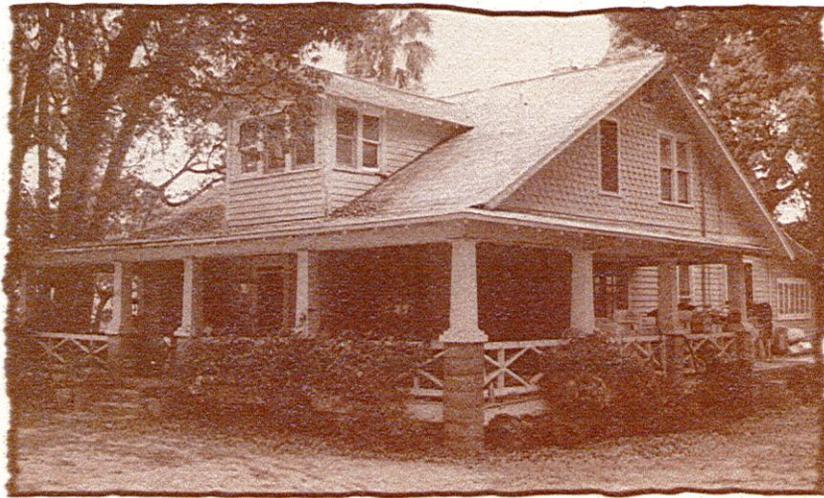
The porch  
of this  
Craftsman  
Bungalow  
on  
Highland  
St. remains  
unaltered.

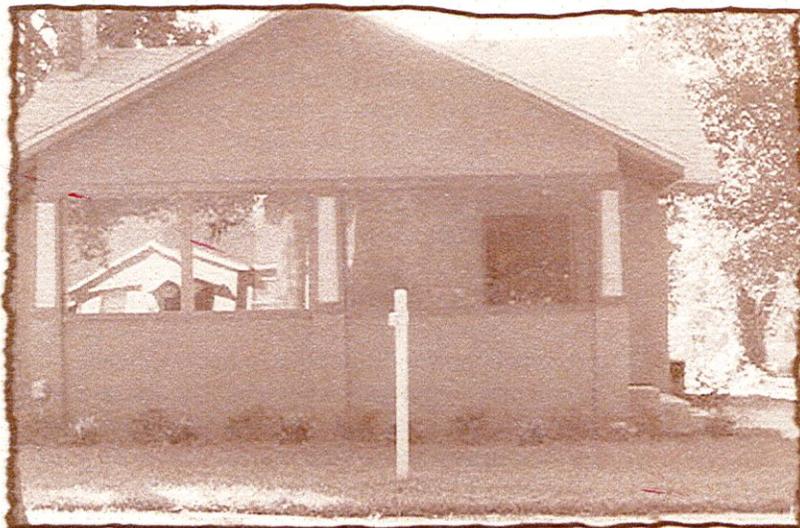
The porch of  
this  
Bungalow on  
6th Avenue  
has been  
appropriately  
enclosed  
with fixed  
glass panels.

There are a number of common problems associated with porch treatments. Owners are often tempted to enclose porches for additional weatherproof living space, especially in smaller homes such as Bungalows, Cottages and some Vernacular structures. Although porch enclosures are generally not recommended, they *can* meet Standards 5, 9 and 10 under *limited circumstances*. Transparent materials, such as clear glass enclosures or screens, which are set behind balustrade and structural systems and maintain the visual openness of a porch are permitted. ***Removal or encasement of significant porch features or enclosure with non-transparent materials are not acceptable treatments.*** Permitted enclosures should be attached in such a way that, if removed, the form and integrity of the porch would remain.

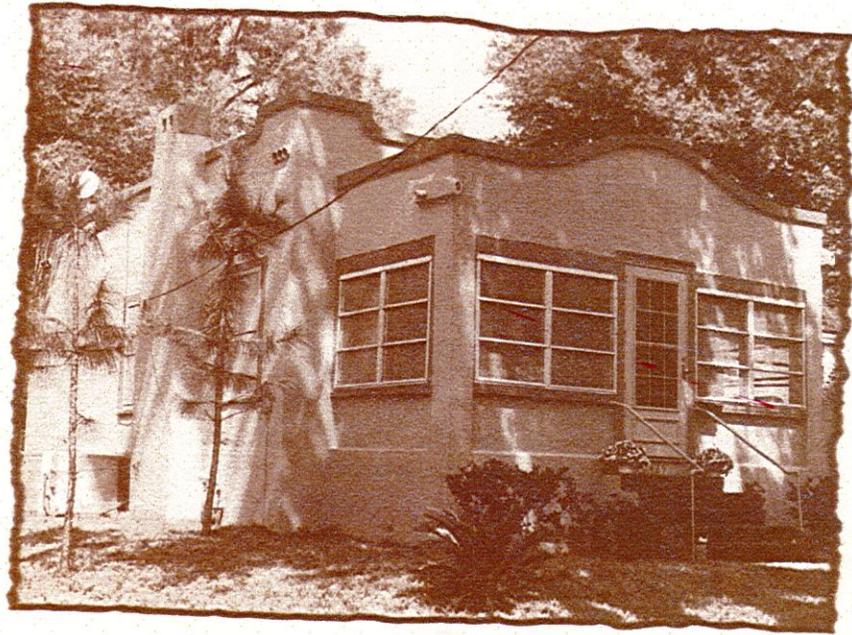
*The original casement windows enclosing the porch on this 1925 Mediterranean Revival home have been replaced with inappropriate awning windows.*

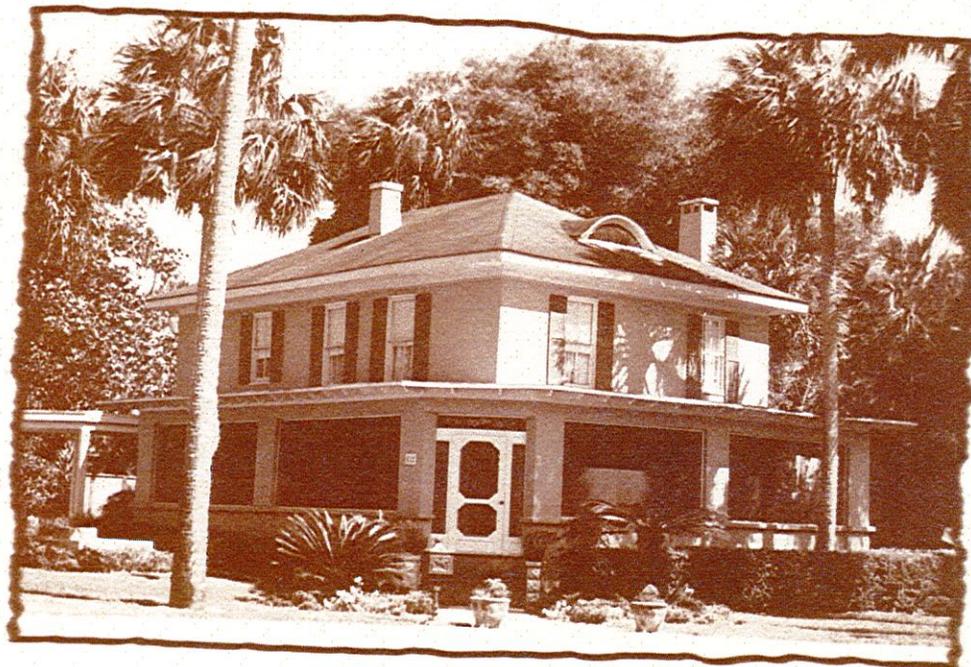
*The porch of the MacGowan-Fowler House, built in 1882, has been appropriately enclosed with screening.*

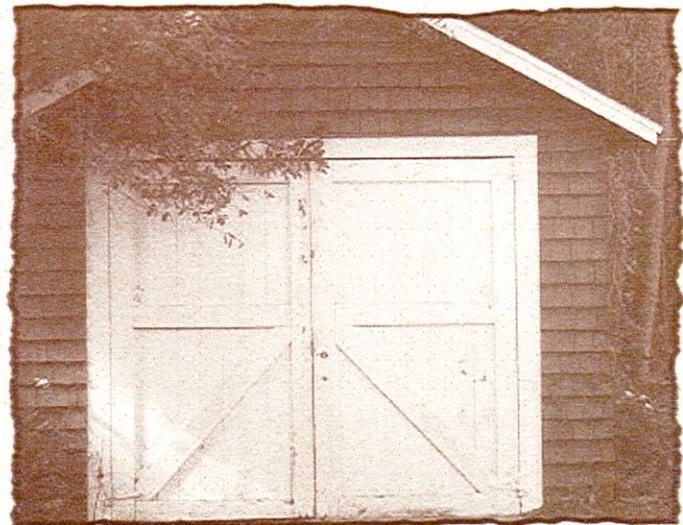
*These garages retain their original doors, still  
in good working order.*

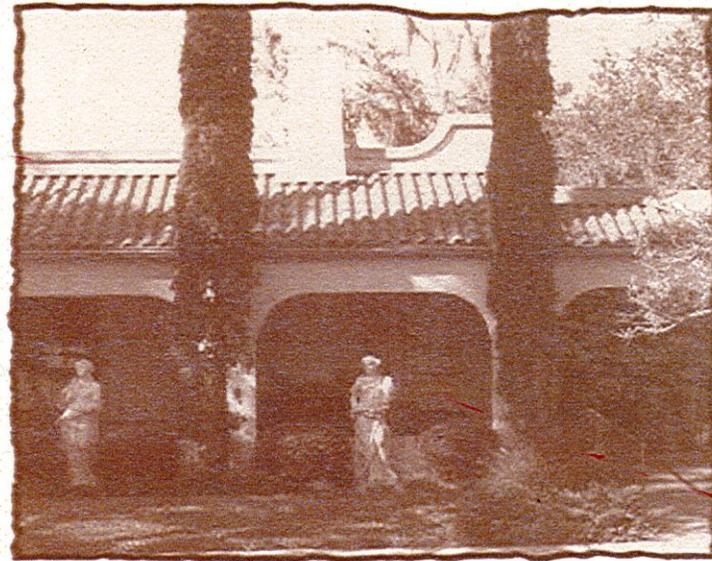
*Barrel Tiles  
are typical  
roofing  
materials  
used in  
Mediterranean  
Influence  
architecture.*

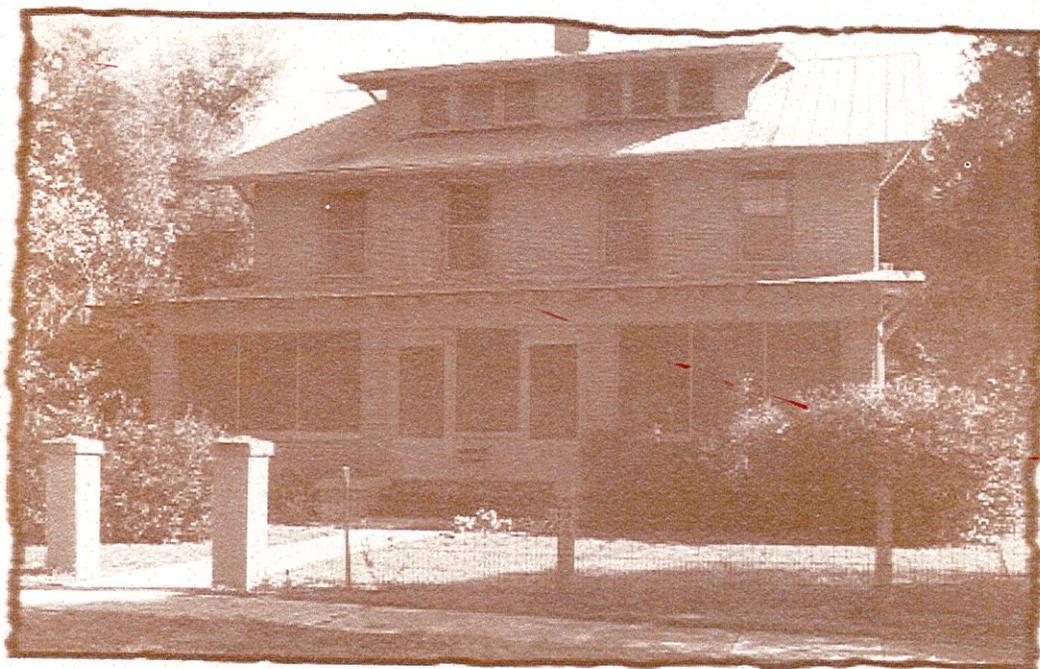
*This brick duplex on Tremain St. exhibits many of the features so important to our historic neighborhoods: a standing seam metal roof, scalloped wire fencing & the original screened porch.*

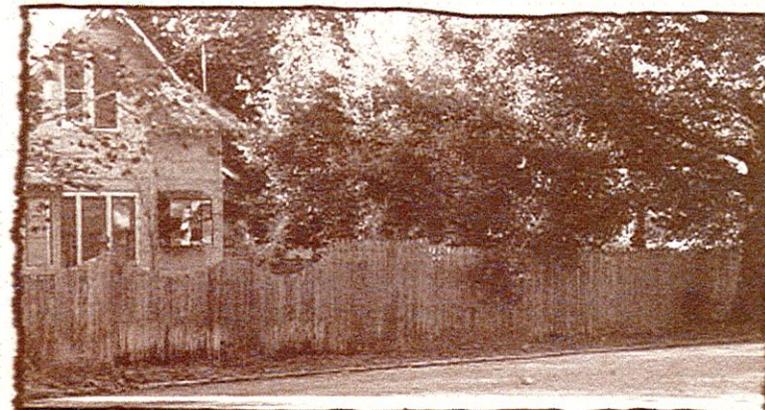
*An inappropriate stockade fence obscures the beauty of this historic home.*

- Removing historic fences and walls.
- Concrete block, ornate iron or wooden, rough cedar, post and rail, chain link or hurricane fences.
- Fences of inappropriate scale that obscure the overall design of a building and its individual features.
